**DEVELOPMENT OF  
HIGH STRENGTH COLUMBIUM  
AND TANTALUM ALLOY TUBING**

**THIRD QUARTERLY PROGRESS REPORT**

**JUNE 1, 1963 TO AUGUST 31, 1963**

**Astronuclear Laboratory  
Westinghouse Electric Corporation**

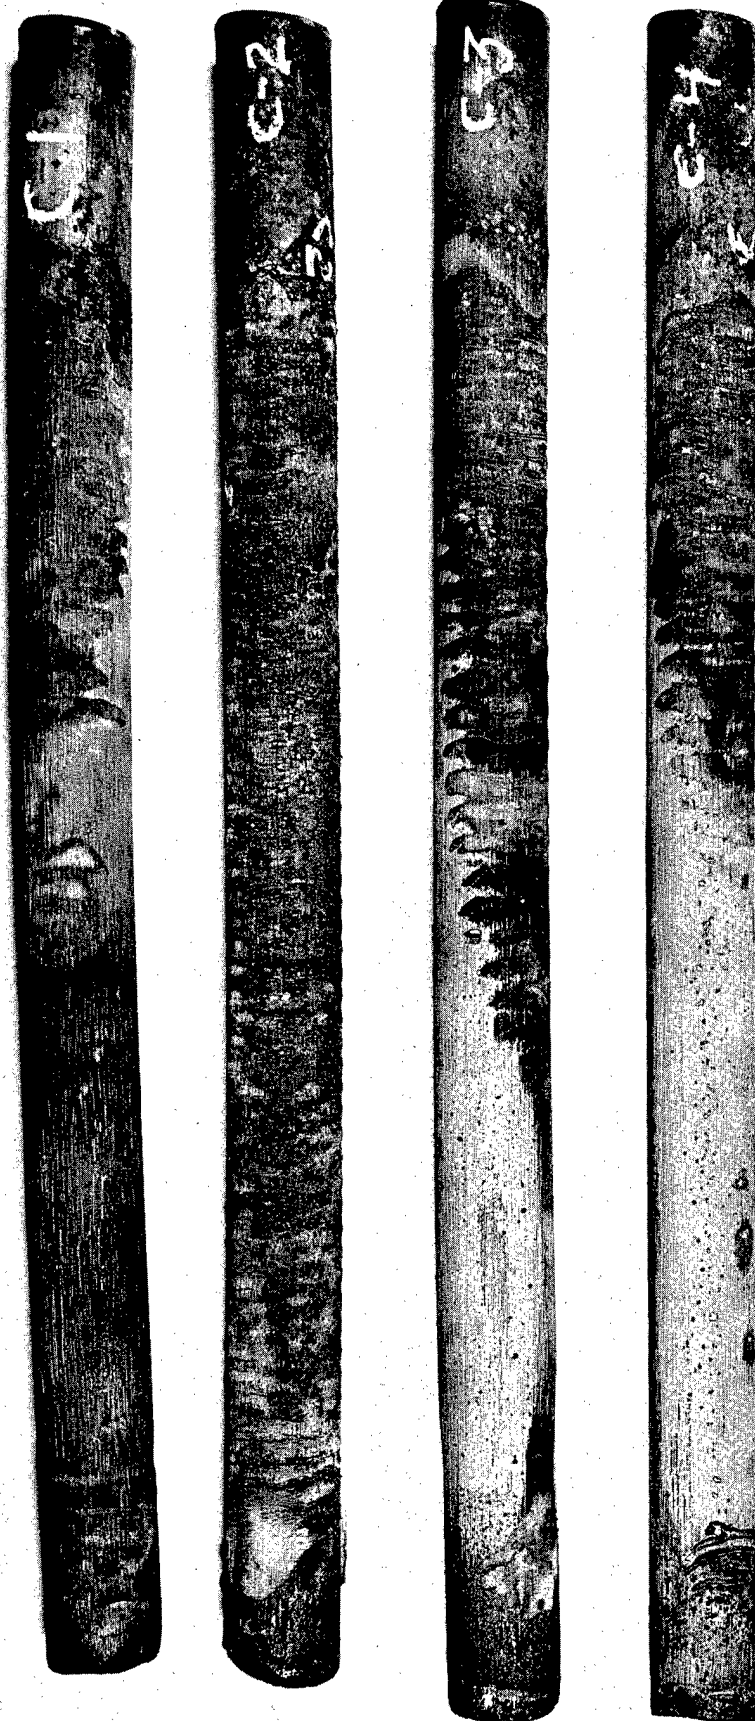
Figure 10 - Phase II B-66 Tube Blank Extrusions

Extrusion of the Phase II B-66 and T-111 billets to a nominal 2 inch O.D. x 0.25 inch wall tube blank was accomplished at the facilities of Nuclear Metals Inc. on July 23 and 24, 1963. The results of the tube blank extrusion are summarized in Table IV. The mild steel clad extrusion billets were heated in an argon purged retort for a minimum of four hours prior to extrusion. For the B-66-II-1 extrusion, the mandrel was heated to 900°F. However, during the extrusion the mandrel hung up in the billet and was pulled through the die. The mandrel was not heated for the balance of the extrusions. T-111-4 stalled the press for no apparent reason. This billet was ~~reprocessed~~ remachined at Nuclear Metals Inc. and then returned to WANL for annealing. The billet was annealed for one hour at 1600°C (2900°F). The annealed hardness was 225 DPH. Eight pounds were lost from T-111-4 during the re-machining operation, thus reducing the total starting weight of the Phase II T-111 extrusion billets to 142 pounds. T-111-4 was re-extruded successfully on September 9, 1963. The mild steel cladding was removed from the extrusions by pickling. The B-66 and T-111 tube blank extrusions are shown in Figures 9 and 10. Moderate to severe rippling was observed on all the extrusions with the exception of T-111-4 which was free of ripples. B-66-II-2 exhibited generally severe rippling and cir-

cumferential cracking which was attributed to excessive extrusion speed. The rippling on the balance of B-66 and T-111 extrusions was confined to localized areas. Representative defective and satisfactory areas of the B-66 and T-111 extrusions are shown in Figures 11 and 12.
